PROPERTY INSPECTION REPORT

10945 Hortense Ave., Unit 111, North Hollywood, CA 91602

Inspection Date: 9/17/2020
Report Number: 2020091701DC
Real Estate Agent: Tony Acereto
Home Inspector: David Cruz

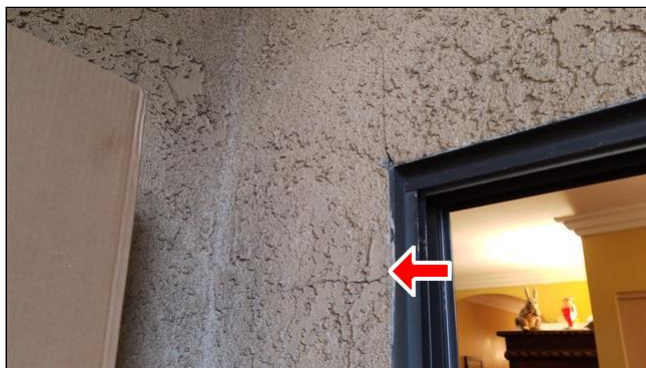
2.2 Item 1(Picture)

Cracks/holes observed at rear wall cladding. Suggest repair.

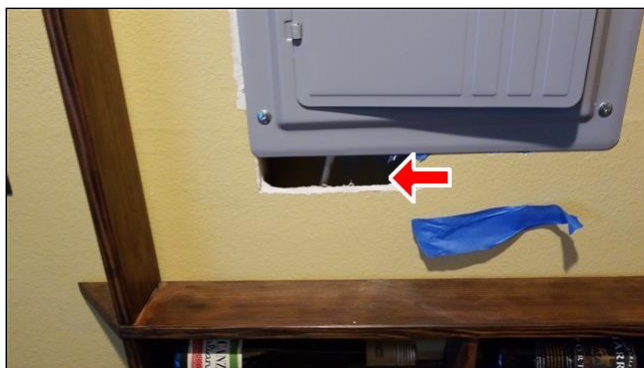
4.3 Item 1(Picture)

🏠 Unprotected wiring observed at hallway. Recommend correcting.

Unprotected wiring observed at hallway. Recommend correcting.

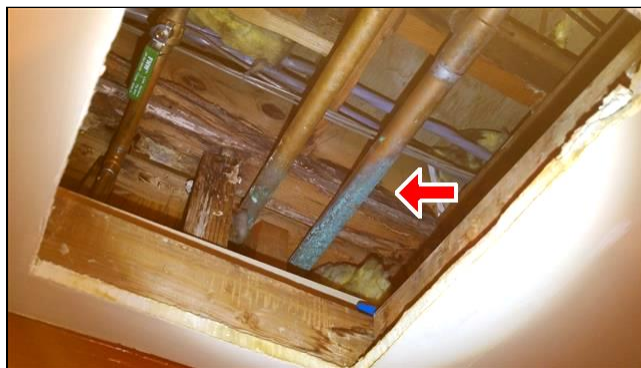
5.1 Item 1(Picture)

📍 Corrosion observed at copper piping. Recommend repairs.

Corrosion observed at copper piping. Recommend repairs.

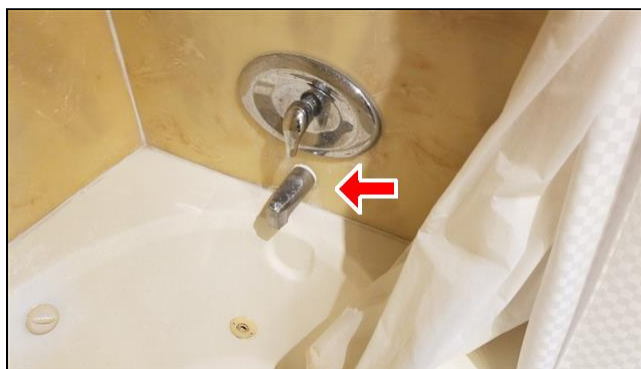
5.5 Item 1(Picture)

📍 (1) Master bathroom tub faucet is not secure. Recommend correcting.

(1) Master bathroom tub faucet is not secure. Recommend correcting.

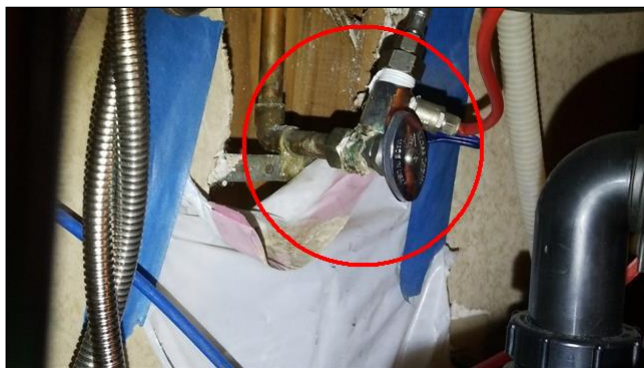
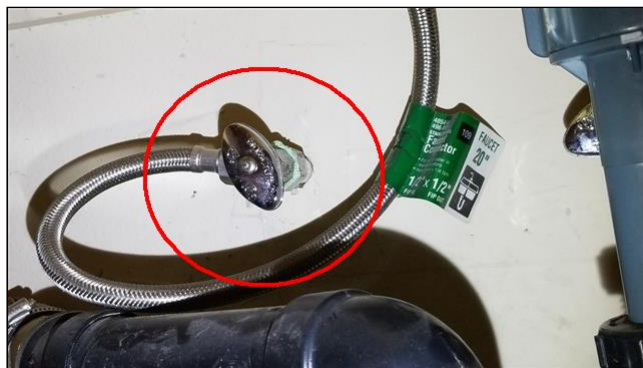
5.5 Item 2(Picture)

↑ (2) Corrosion observed at the kitchen and hallway bathroom sink shut off valves. Recommend repairs.

(2) Corrosion observed at the kitchen and hallway bathroom sink shut off valves. Recommend repairs.

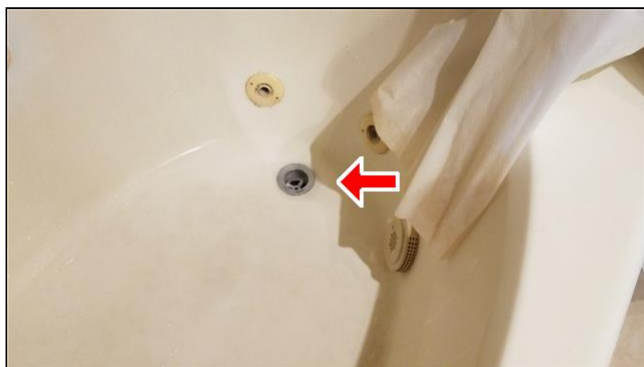
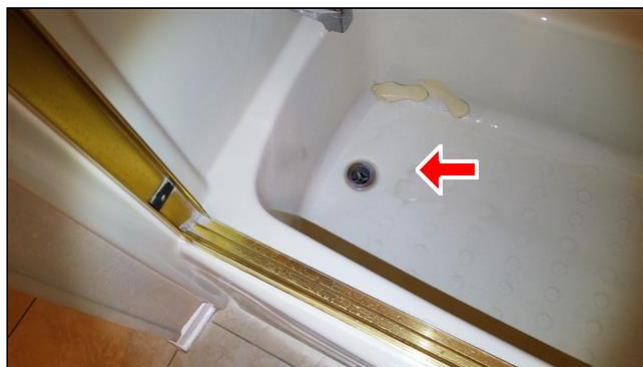
5.5 Item 4(Picture)

↑ (3) Drain stoppers are not installed at the bathroom tubs. Recommend correcting.

(3) Drain stoppers are not installed at the bathroom tubs. Recommend correcting.

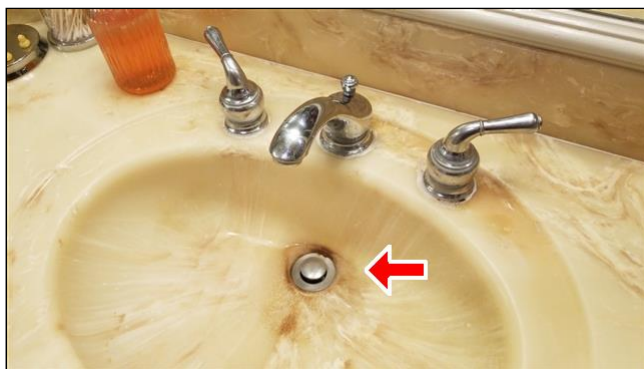
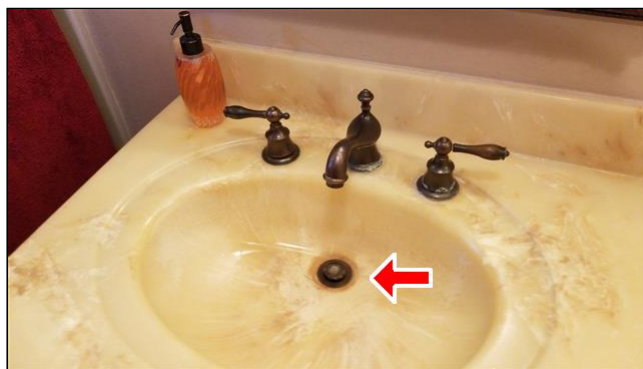
5.5 Item 6(Picture)

(4) Inoperable drain stopper observed at the bathroom sinks. Suggest correcting.

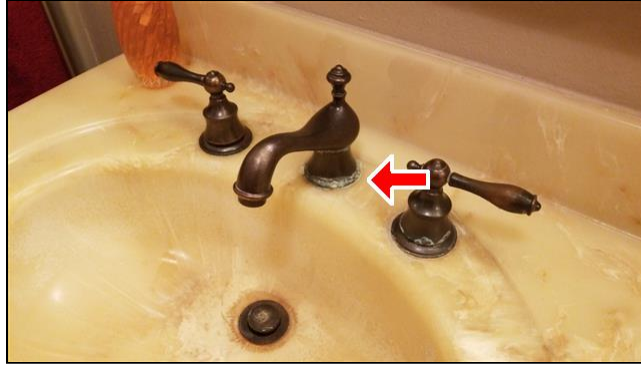
5.5 Item 8(Picture)

(5) Corrosion observed at bathroom sink faucets. Suggest maintenance.

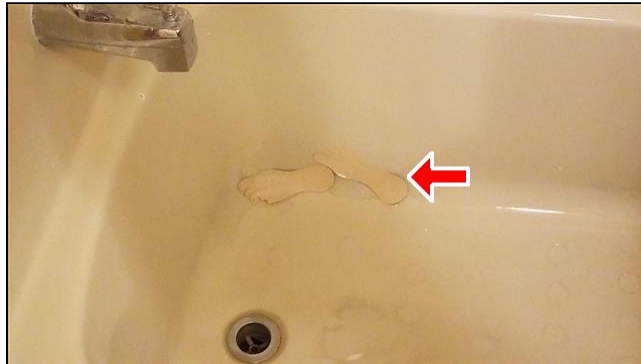
5.6 Item 1(Picture)

🏠 (2) Deteriorated tub/shower surface at hall bathroom. Recommend repair.

(2) Deteriorated tub/shower surface at hall bathroom. Recommend repair.

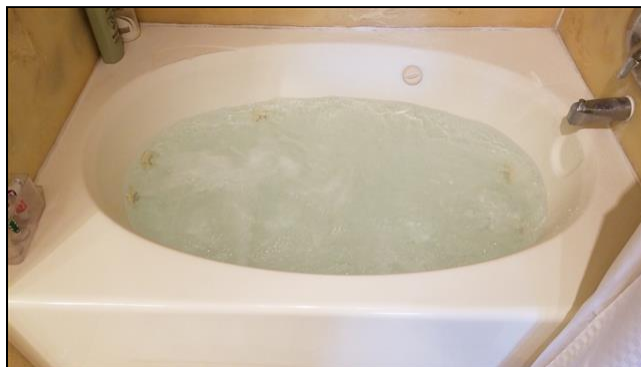
5.6 Item 2(Picture)

🏠 (3) Jetted tub is hard wired/GFCI is not installed. Recommend installing a GFCI outlet and an Underwriters Laboratories (U.L.) listed cord.

(3) Jetted tub is hard wired/GFCI is not installed. Recommend installing a GFCI outlet and an Underwriters Laboratories (U.L.) listed cord.

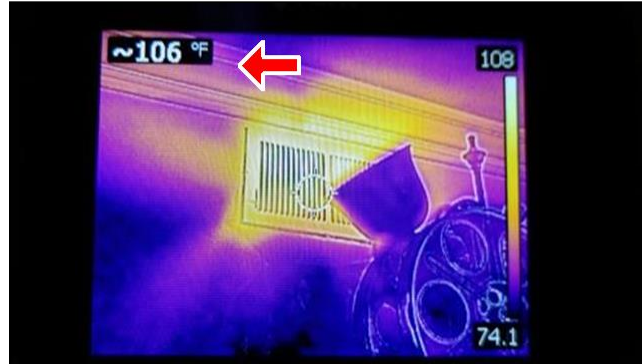
7.0 Item 1(Picture)

(1) A heat pump is a sealed, compressor-cycle air conditioning system that can operate in reverse. Adequate air flow is important to the efficiency of this unit, therefore, the filter should be kept clean.

(2) Unit was tested using normal operating controls and provided heat at the service registers. Changing the air filters, servicing and regular maintenance of the components is recommended to prolong the service life of the system.

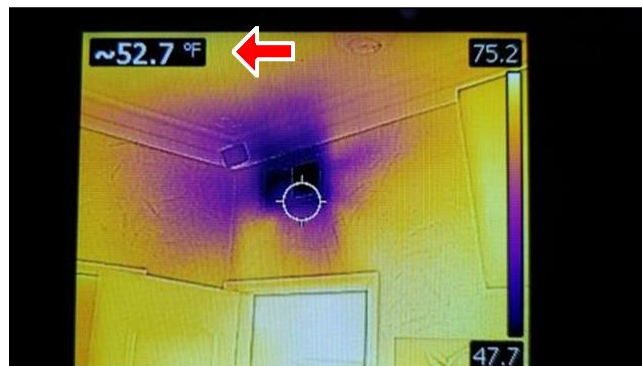
7.1 Item 1(Picture)

(2) The air conditioning system was operated using normal operation controls (thermostat). The difference between the return air vent and the service registers was between the recommended range of 15 to 20 degrees Fahrenheit. Changing the air filters, servicing and regular maintenance of the components is recommended to prolong the service life of the system.

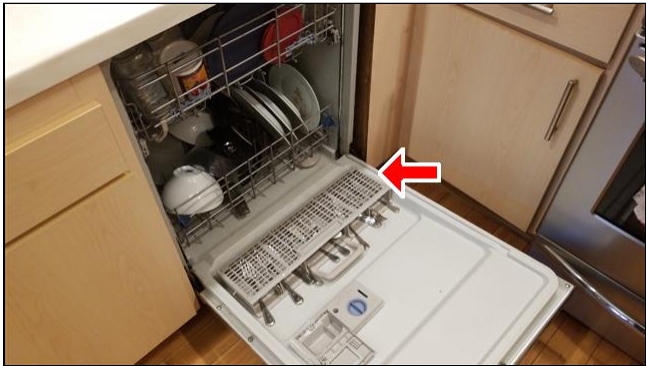
9.0 Item 1(Picture)

Door spring is inoperable or missing. Recommend repair.

Door spring is inoperable or missing. Recommend repair.

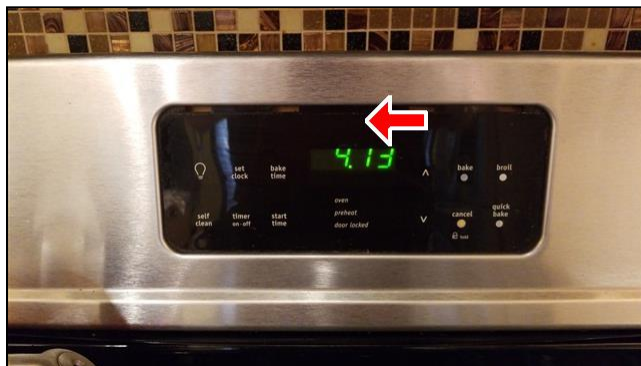
9.1 Item 1(Picture)

🏠 (1) Anti-tip bracket is not installed. Recommend installing.

🏠 (2) Burner(s) did not ignite at front/left. Recommend correcting.

🏠 (3) Digital display is not centered. Recommend correcting.

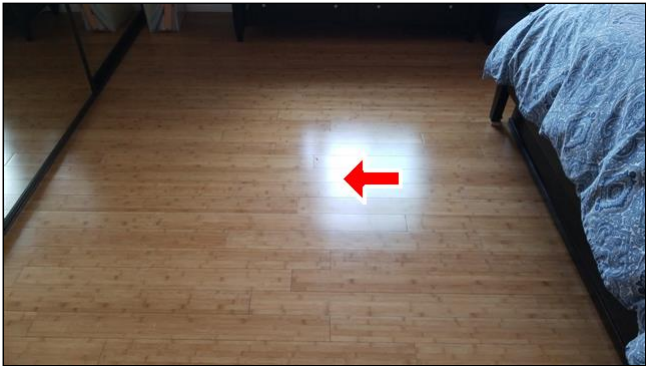
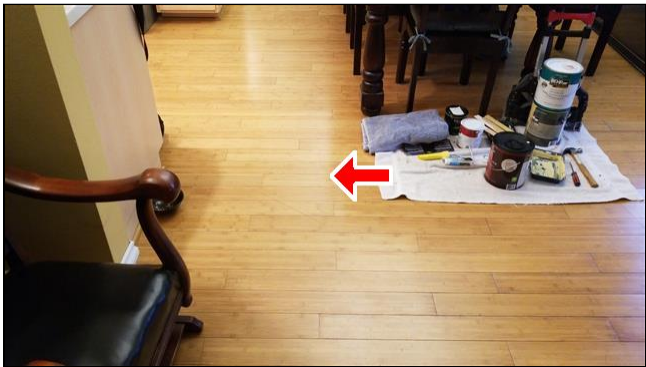
10.0 Item 1(Picture)

Sloping floors observed at bedrooms, hallway and dining room. Recommend correcting.

Sloping floors observed at bedrooms, hallway and dining room. Recommend correcting.

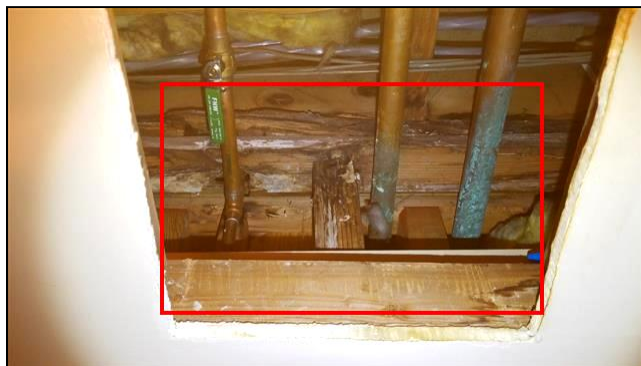
10.1 Item 1(Picture)

- 🏠 (1) Moisture damage observed at hall bathroom ceiling access. Hidden damage may not be observable. Recommend further review by a qualified professional.

(1) Moisture damage observed at hall bathroom ceiling access. Hidden damage may not be observable. Recommend further review by a qualified professional.

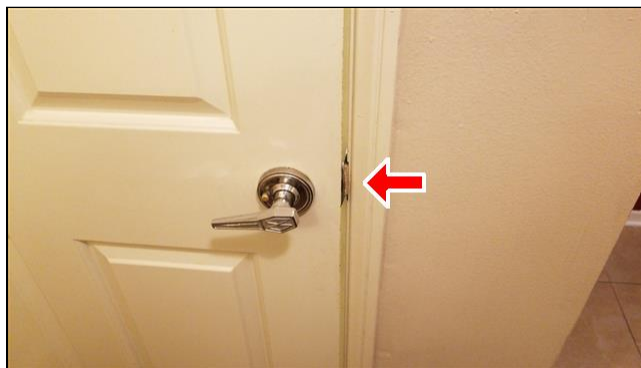
10.2 Item 2(Picture)

(2) Hall bathroom door rubs on strike plate when opening/closing. Suggest correcting.

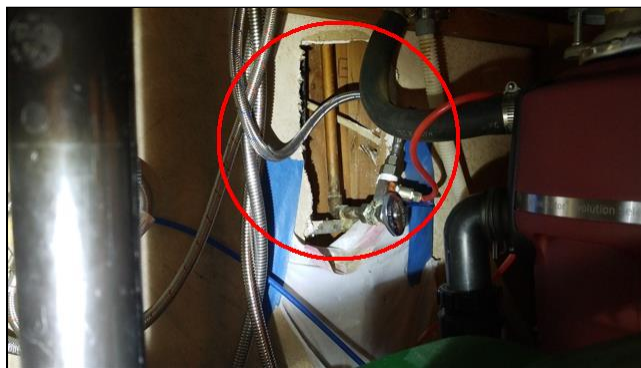
10.4 Item 1(Picture)

- 🏠 (1) Hole observed around the kitchen sink drain line. Recommend repair.

(1) Hole observed around the kitchen sink drain line. Recommend repair.
